Manhole Inspection Summary

Manhole # S29GG_035MH

Insp Date: **12/29/06 11:50 AM**

Location Address: **MCMECHEN ST**

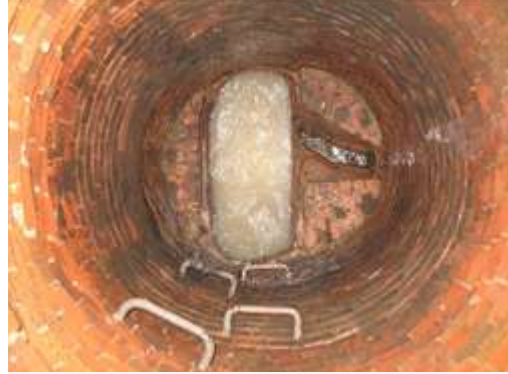
Top View

Adjustment and Barrel infiltration.
Corroded steps. Evidence of surcharge.

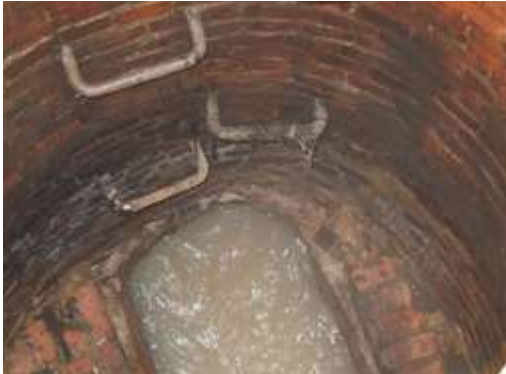
Defect

Barrel infiltration. Evidence of surcharge.

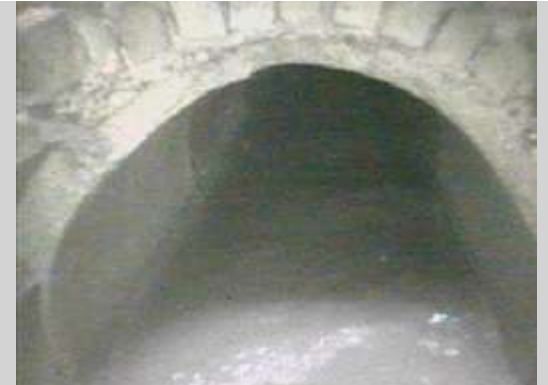
21 in. Circular Gravity Sewer Pipe Out @ 12 O'Clock

Infiltration: **Evidence** Pipe Seal Cond: **Unknown**

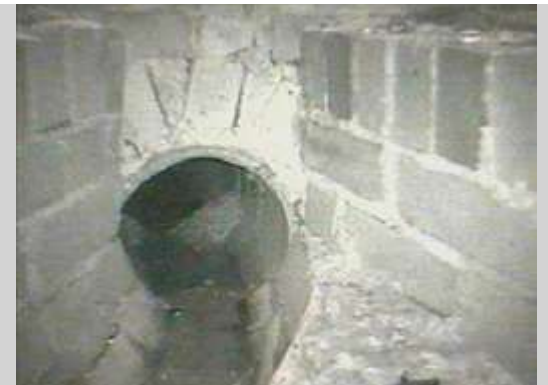
8 in. Circular Gravity Sewer Pipe In @ 3 O'Clock

Infiltration: **Evidence** Pipe Seal Cond: **Unknown**

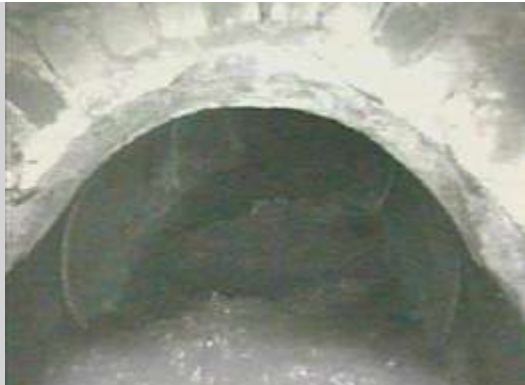
Pipe In @ 6 O'Clock

Infiltration: **Evidence** Pipe Seal Cond: **Unknown**
